Memorandum

To: Mark Raney, Volpe Center Task Order Manager

From: Nick Raines, CDM Field Team Leader

Subject: Flower Creek Investigation Summary

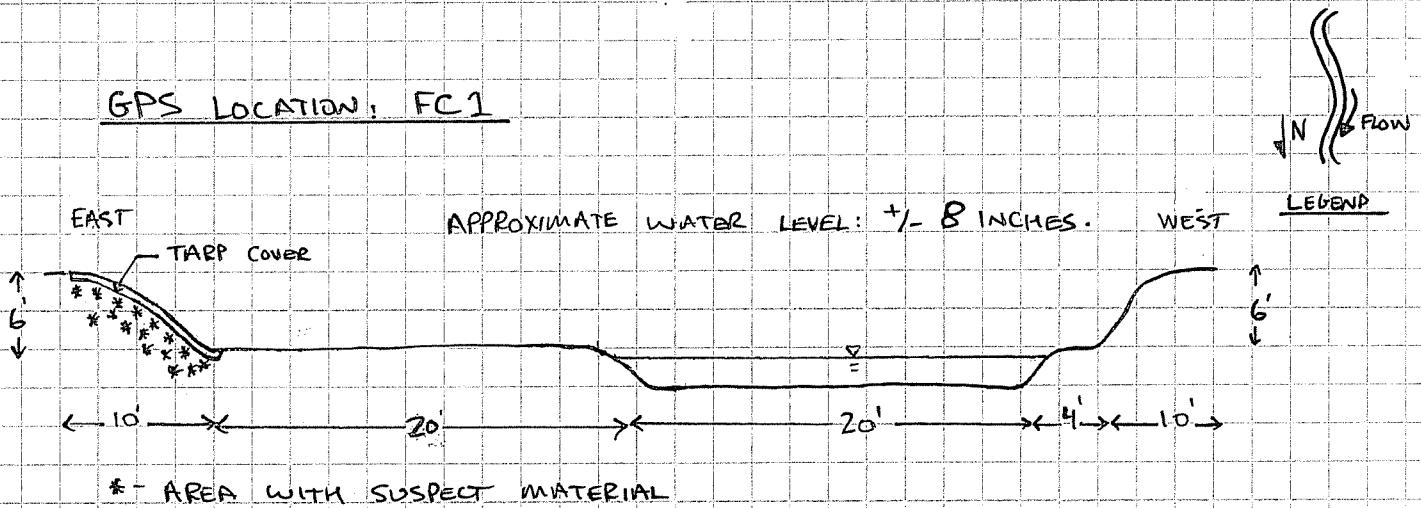
GPS LOCATION: FC1

Located along the east creek bank adjacent to 511 W. Balsam St, this location contains a large deposit of suspect material, with rocks ranging from 1 to 12 inches in diameter. A plastic tarp is currently covering the extent of the suspect material.

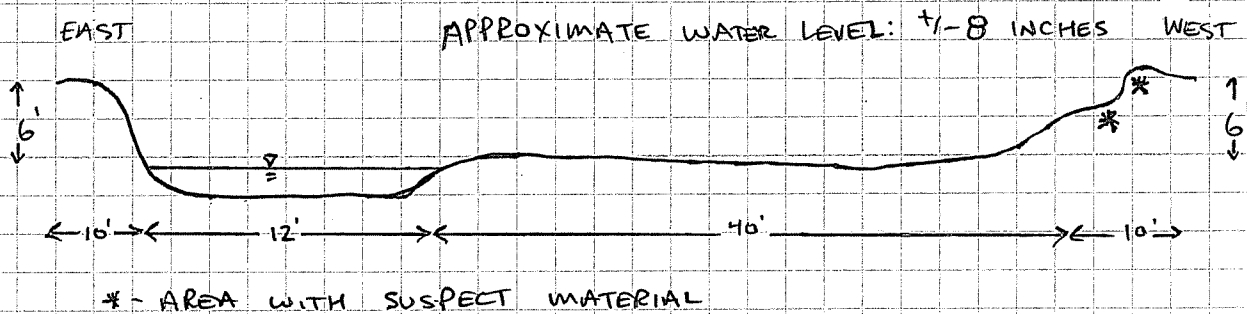
GPS LOCATION: FC2

Located along the west creek bank, this location contains a sparse deposit of highly concentrated suspect material with several rocks that are approximately 12 inches in diameter. There is a soil layer covering the majority of the deposit suspect material.

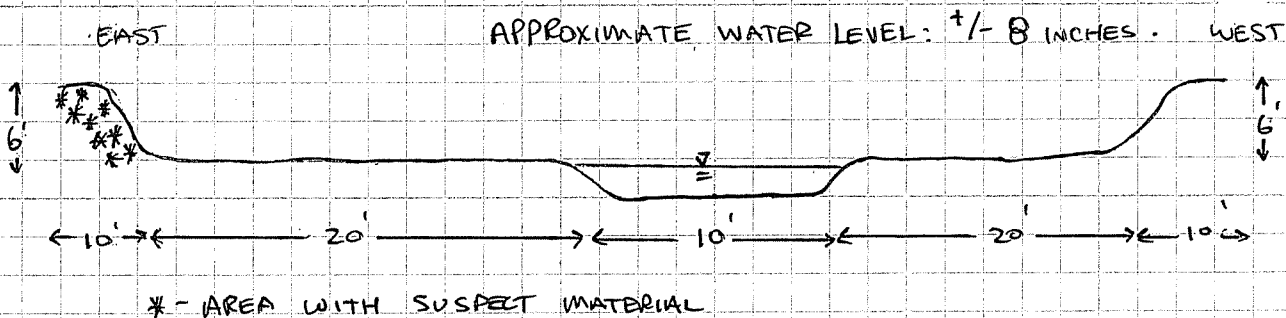
GPS LOCATION: FC3

Located along the east creek bank adjacent to 367 Cedar St Ext, this location contains a large deposit of suspect materials with rocks that are approximately 24 inches in diameter. Small pieces of amphibole and vermiculite were also readily observed at this location.

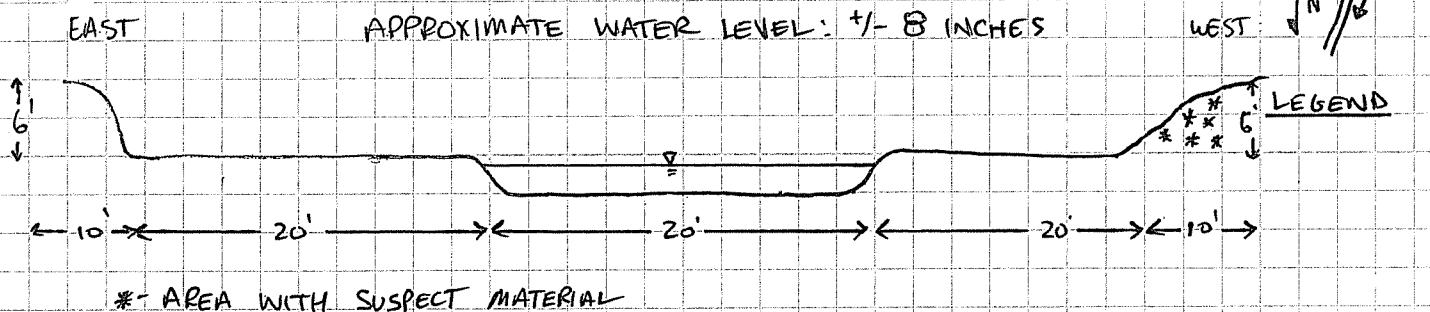
GPS LOCATION: FC4

Located along the west creek bank adjacent to 521 Flower Creek Rd, this location contains a large deposit of suspect material with rocks that are approximately 24 inches in diameters.

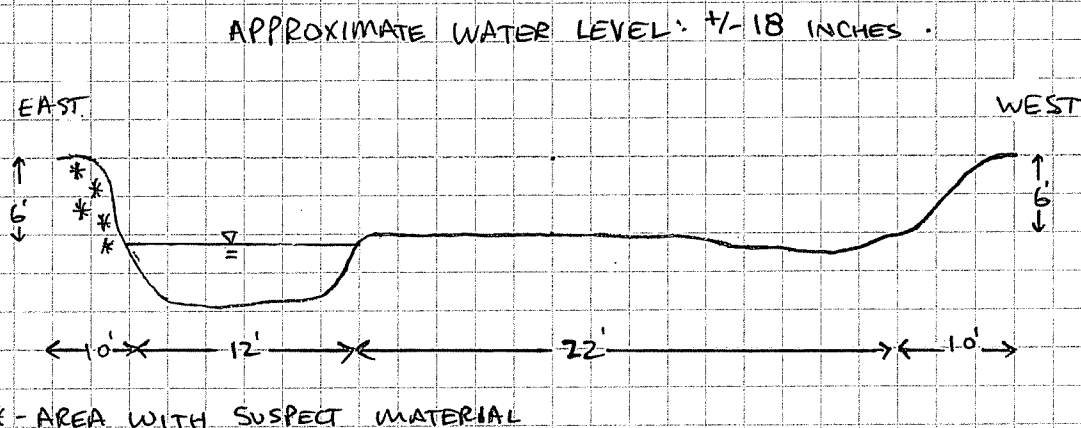
GPS LOCATION: FC5

Located along the east creek bank adjacent to 367 Cedar St Ext, this location contains a large deposit of suspect rocks that are approximately 24 inches in diameters. The material at this location was similar to GPS location FC4.

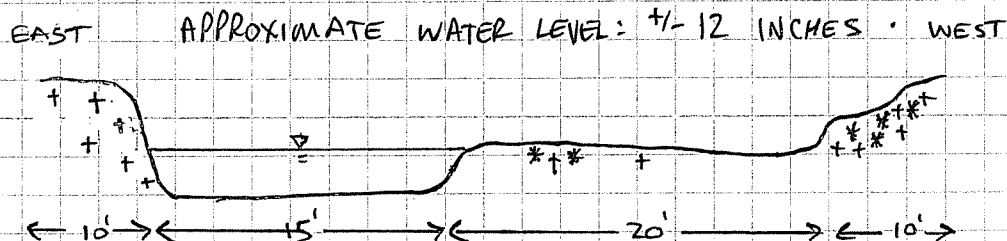
GPS LOCATION: FC6

Starting at this location and continuing upstream, suspect rock was observed sporadically along both creek banks, as well as in some places along the creek bed. This suspect material was similar in size and condition to the material found at locations FC3, FC4, and FC5.

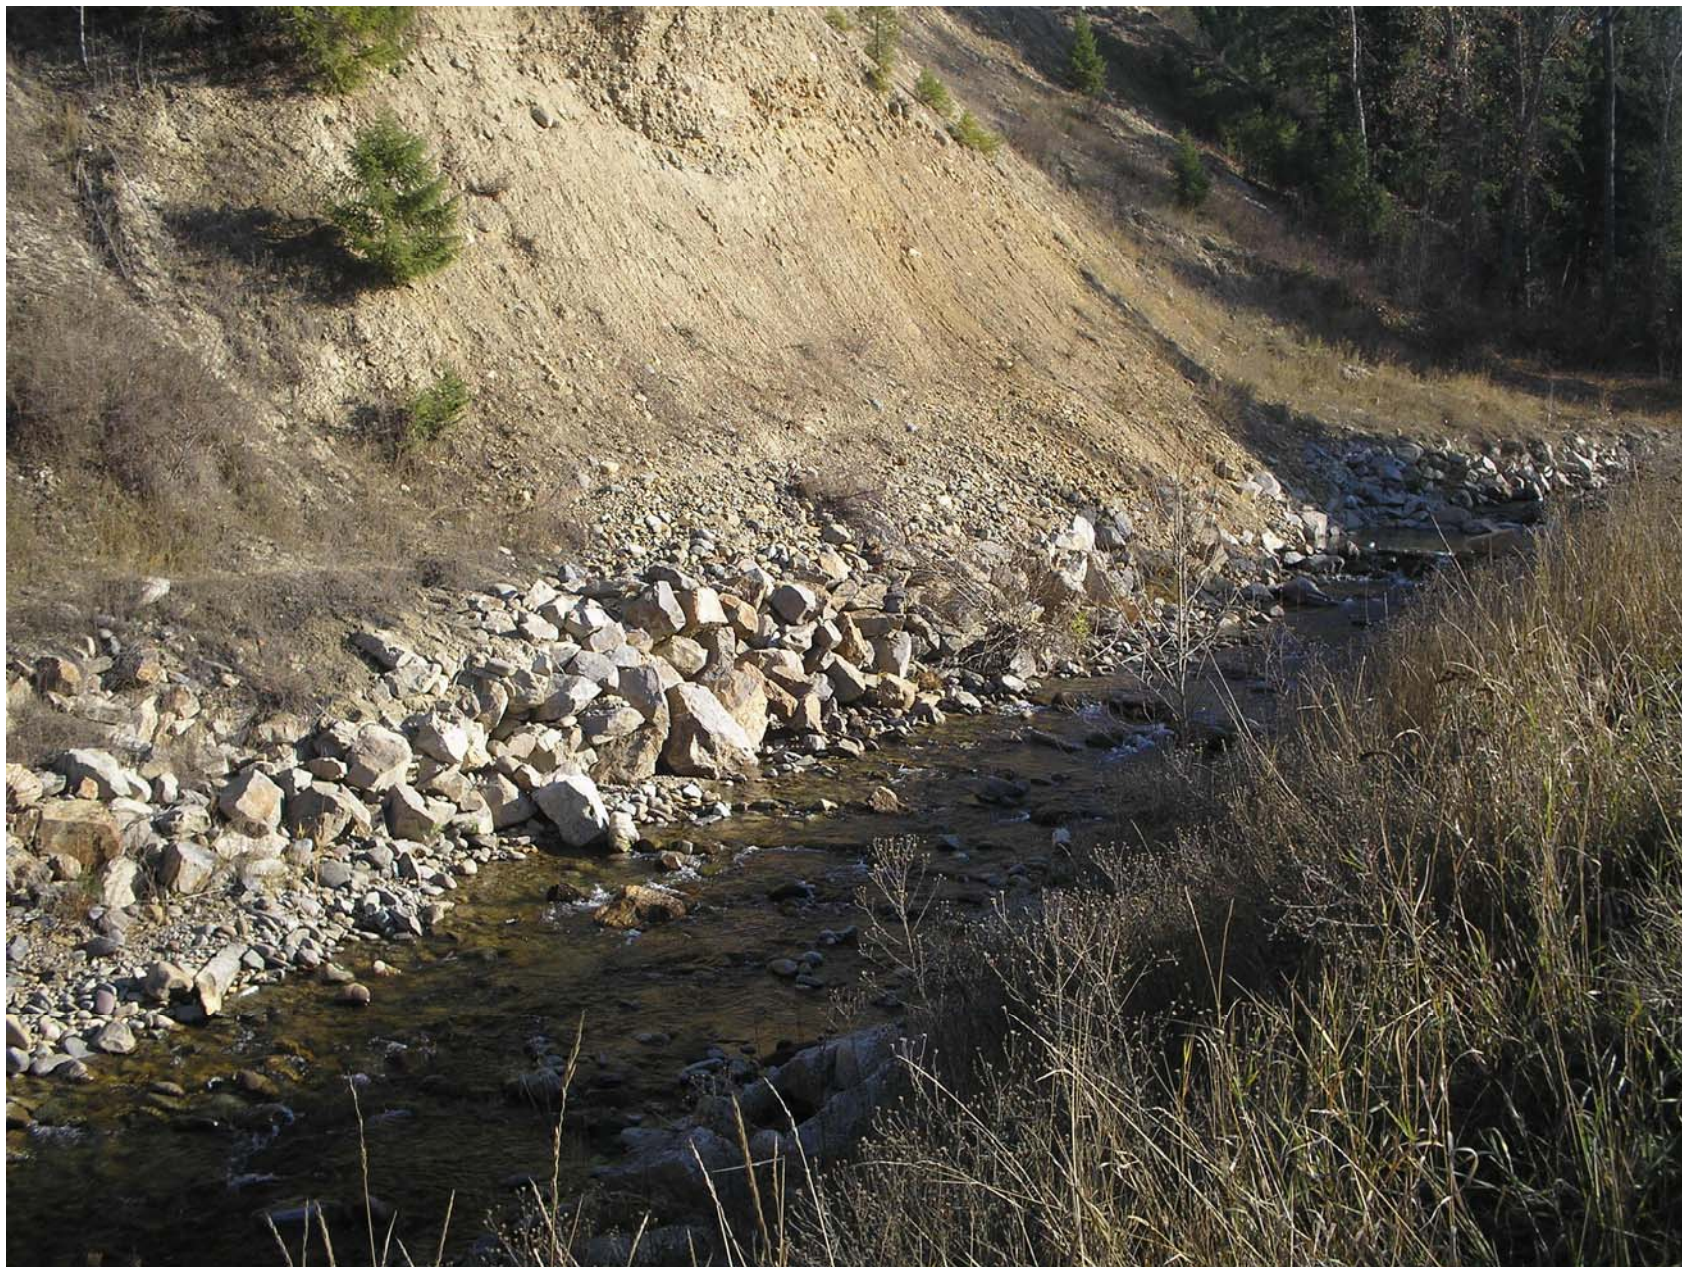
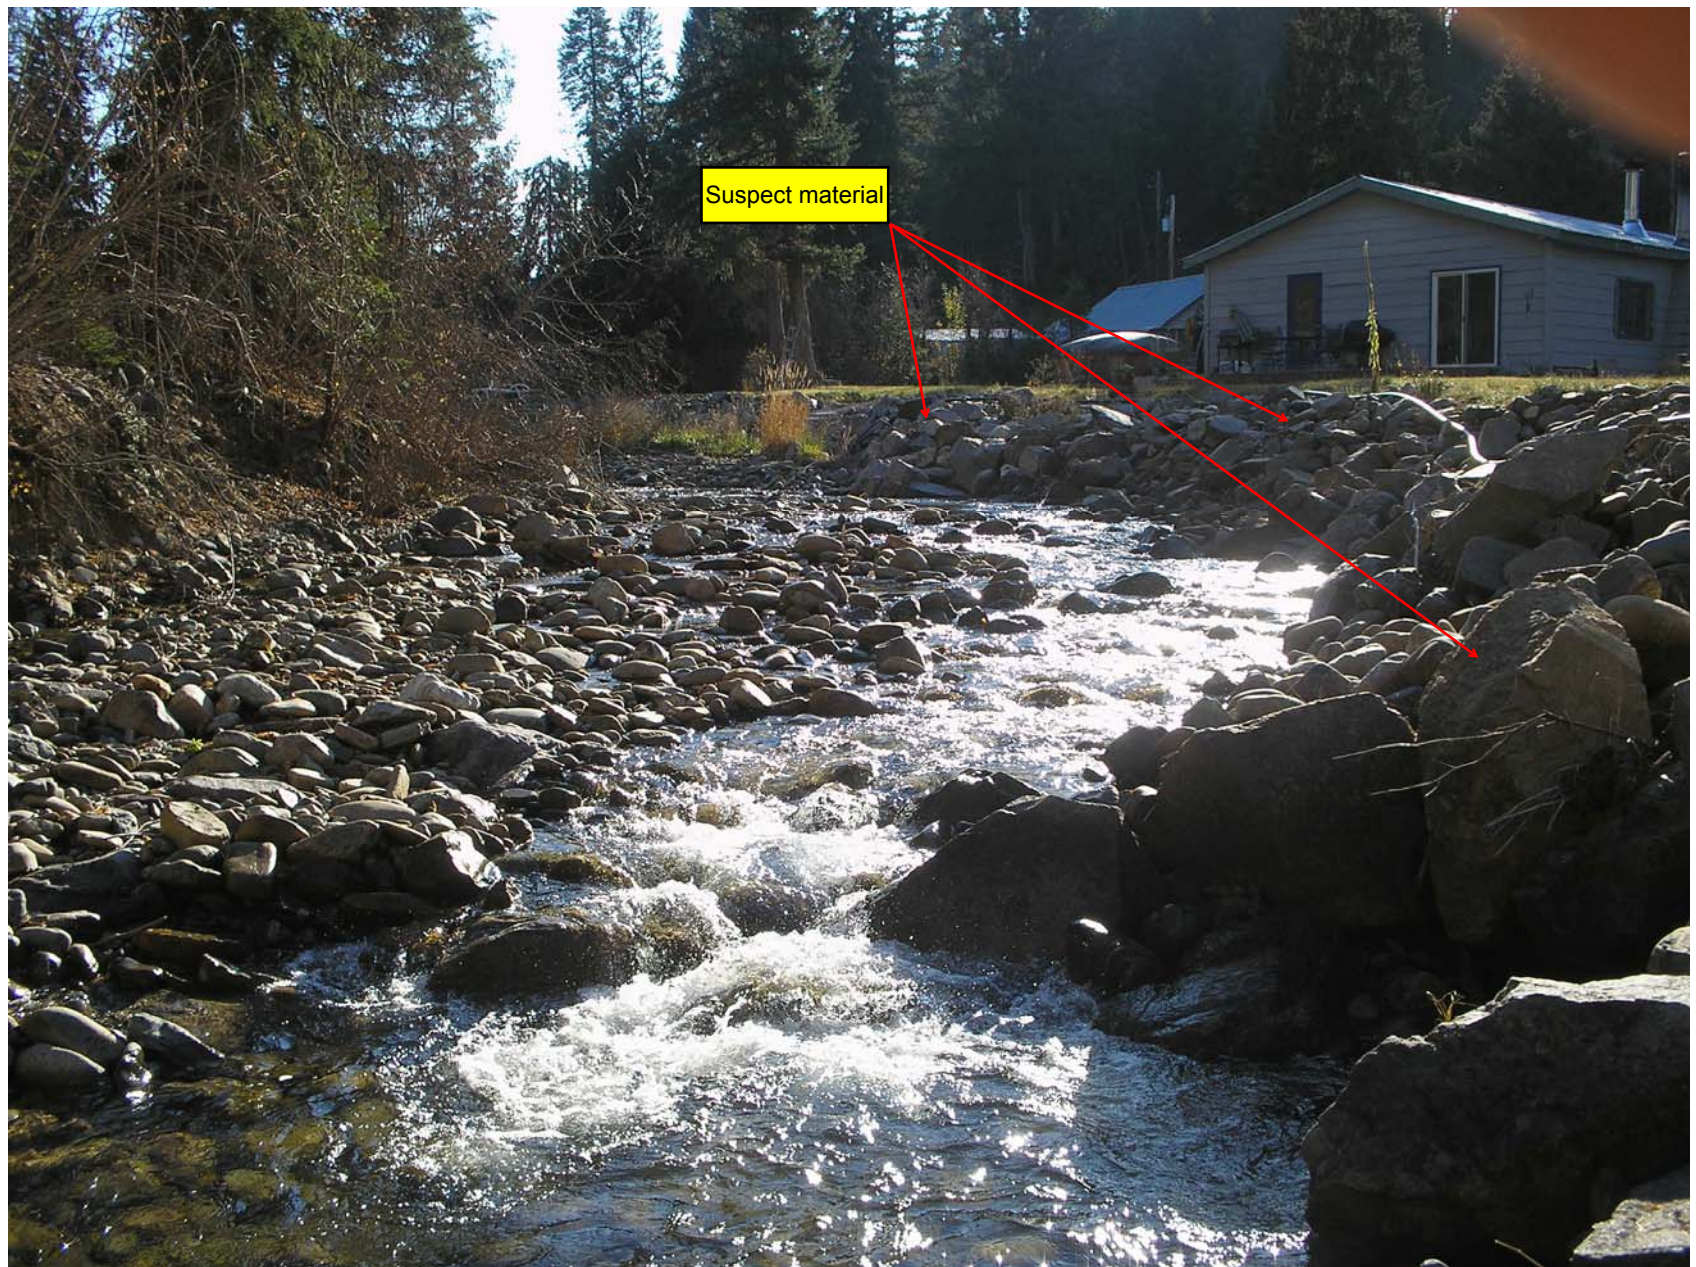
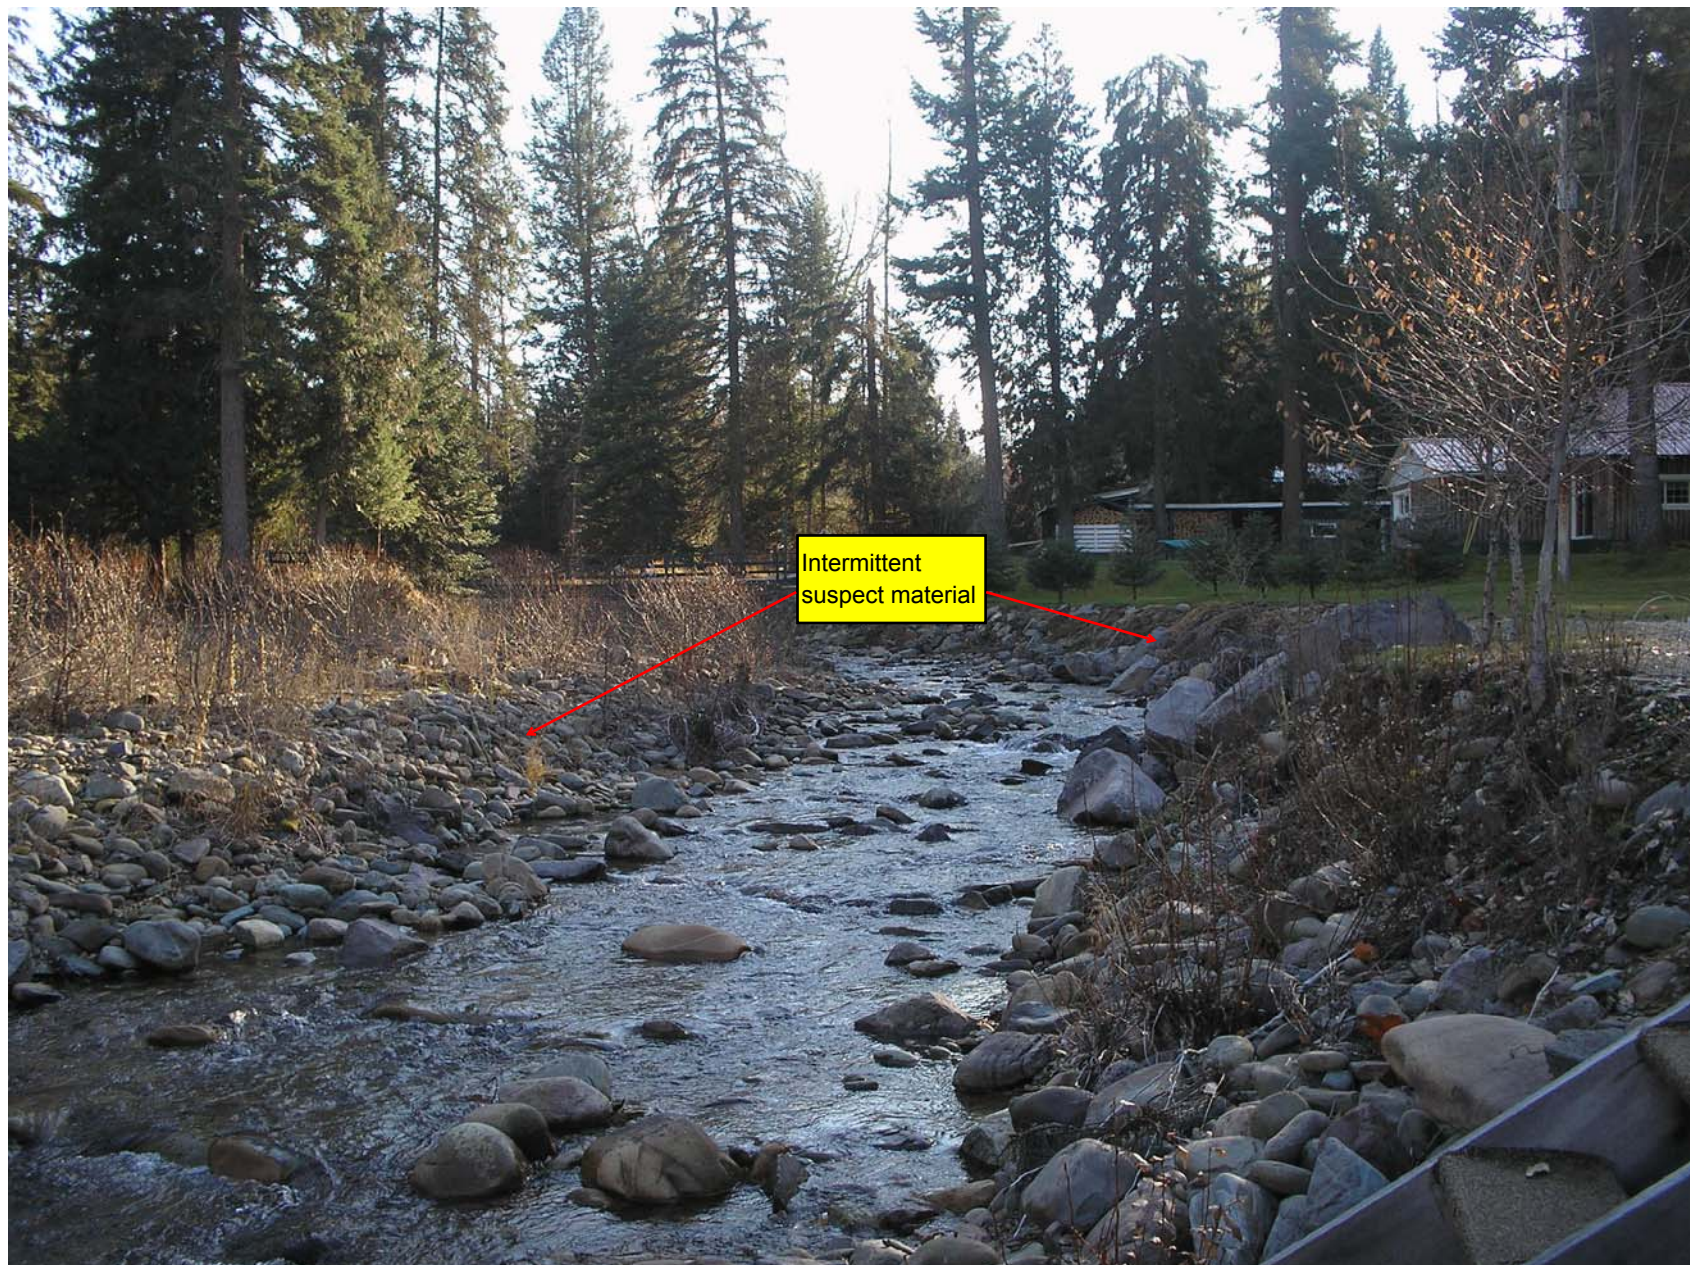
From GPS location FC6, no other GPS locations were established upstream to the investigation limit due to the continuously sporadic nature of the deposited suspect rock.

South of FC6 – Looking Upstream (South)

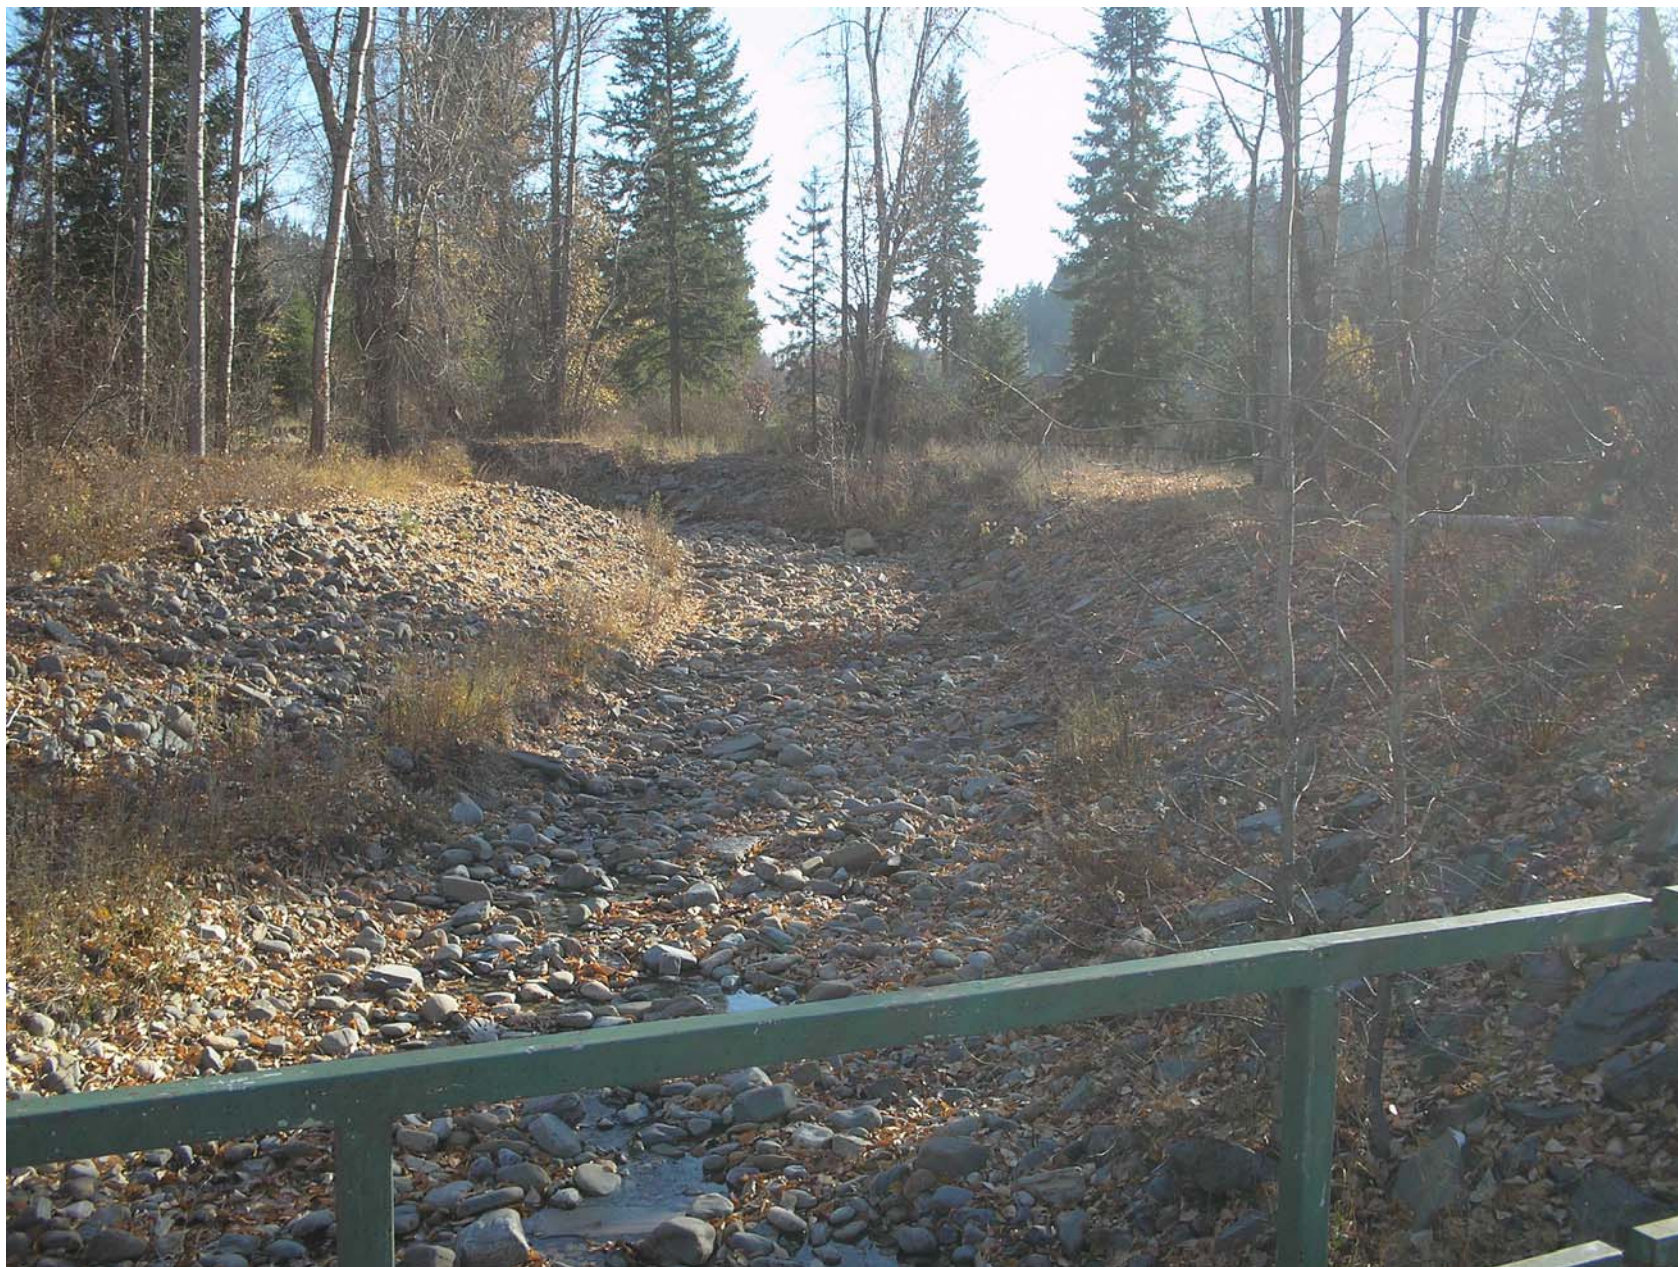
A visual inspection for suspect material was conducted downstream of the West Balsam St bridge to the Kootenai River and no suspect material was observed. However, at least one area was identified as having potential for contamination to be deposited as it is carried downstream. This location is a large overflow pond approximately half way between the upstream and downstream limit of the investigation. At the time of the investigation, this overflow pond was primarily dry, but contained a large amount of small deposited rock.

Overflow Channel – Downstream of West Balsam St, Bridge

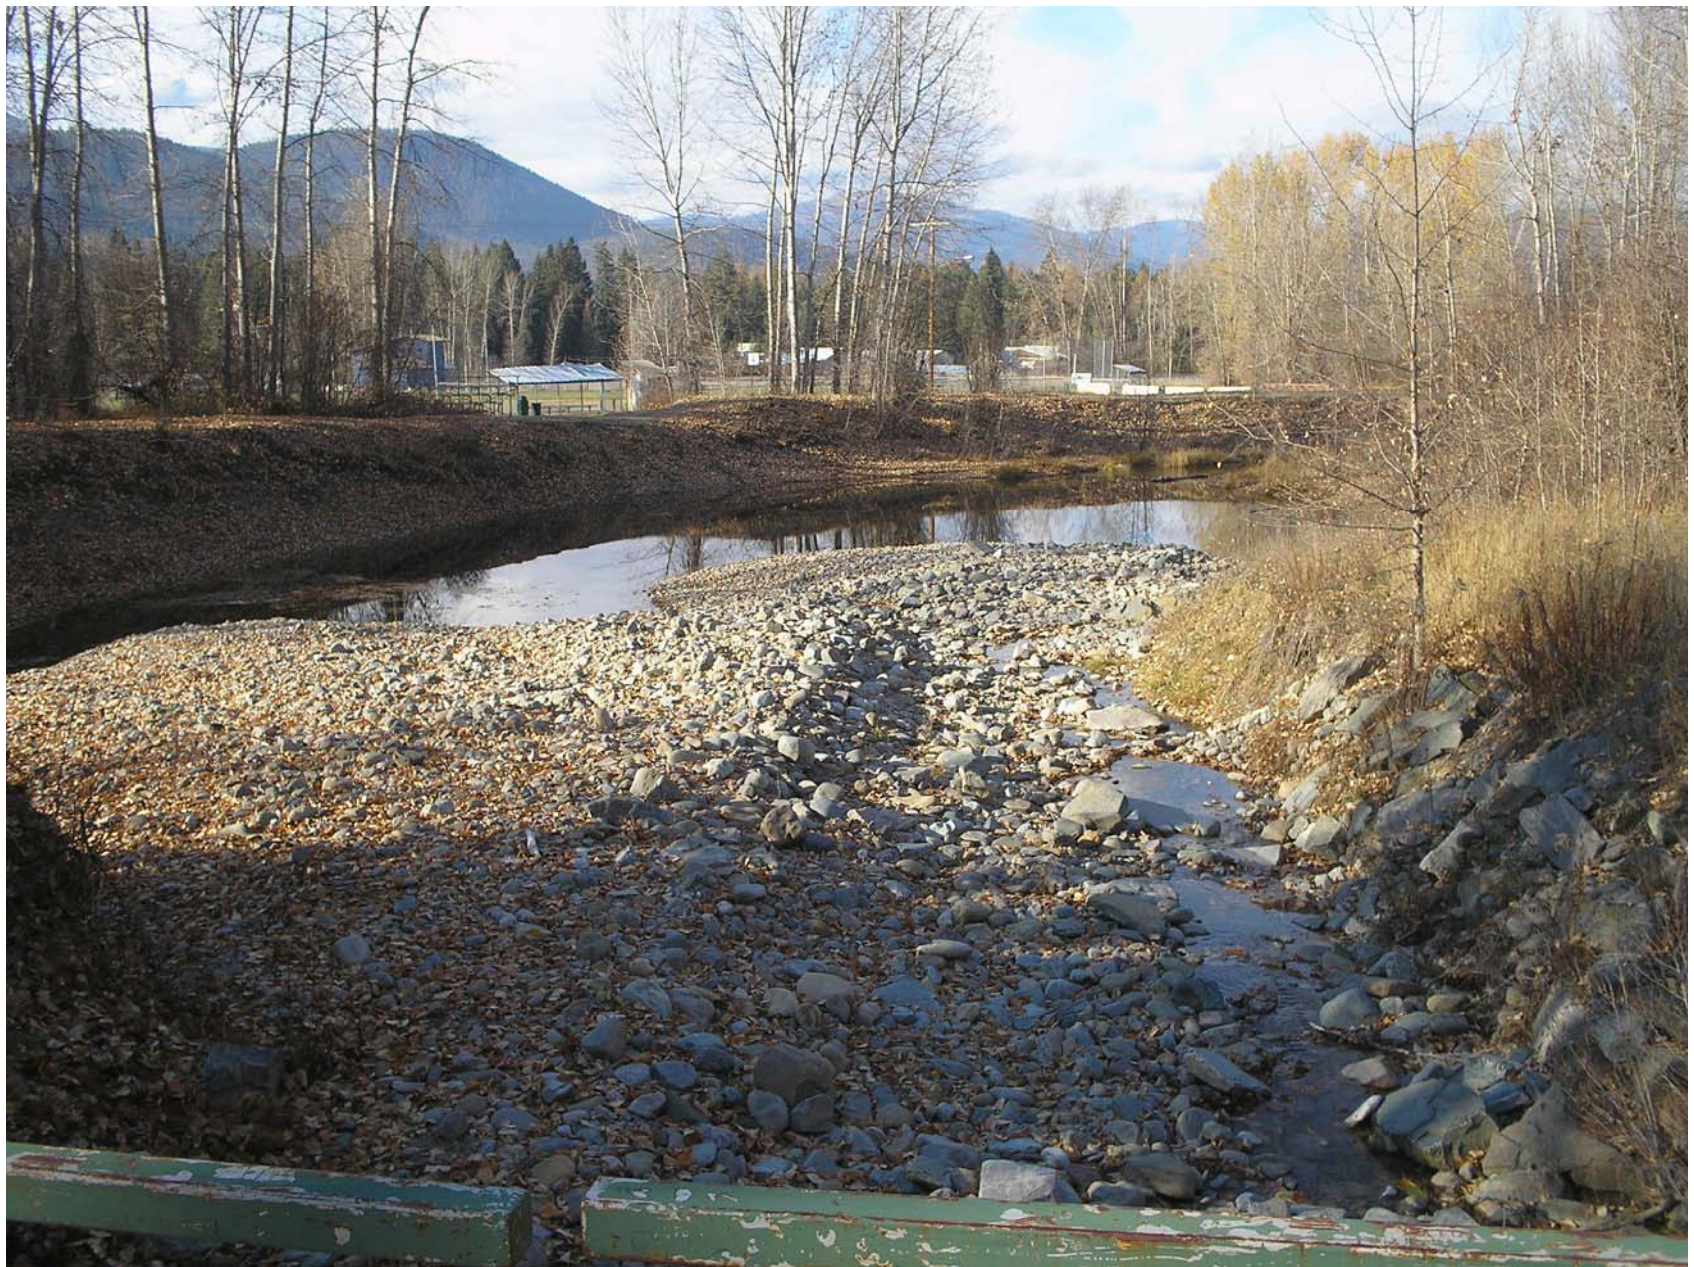
Overflow Pond – Downstream of West Balsam St, Bridge
